**SAS Superstructure**

**Daily Diary Report by Bid Item**

Contract No.: 04-0120F4

**04-0120F4  
04-SF-80-13.2/13.9  
Self-Anchored  
Suspension Bridge****Weather**

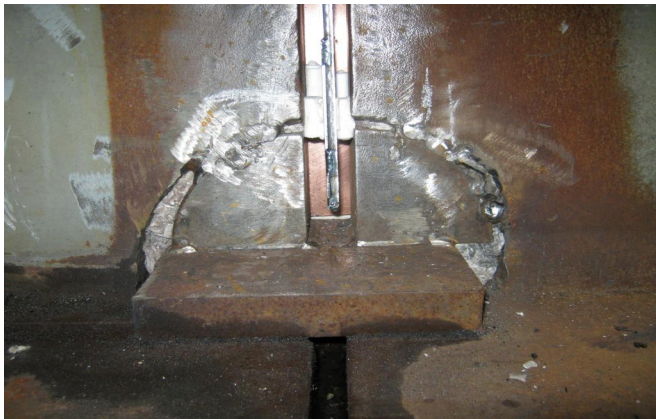
Starting sump with consumable guide installed - note: copper shoes already installed on back side

The 7th ESW weld was done today. It was on the butt joint that connects shear plate a2S to the East shaft. The following is a list of activities for this operation:

- 2 new barrels of weld wire were brought to the site and connected.
- At 09:30, the consumable guide was installed.
- From 09:30 until 11:30, the insulators, volt pick-ups, and cooling shoes were installed.
- From 12:30 until 13:00, QC & production went through their pre-weld checklists.
- At 13:11, the weld was started.
- It took about 1 minute, 50 seconds for the weld parameters to stabilize.
- At 15:34, the weld was low on flux for about 30 seconds, and was running a little loud.
- At 17:20, the weld was ended in the run-off tab.

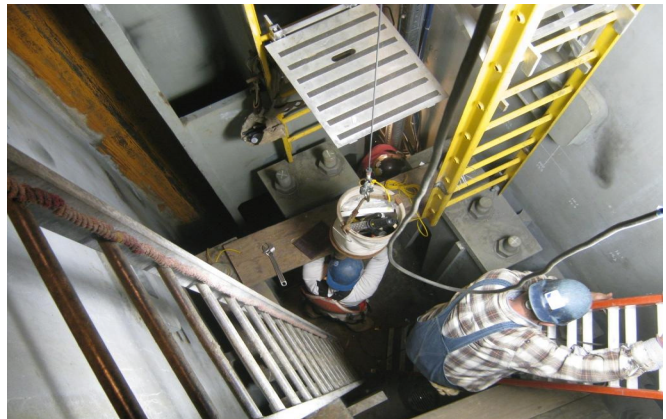
Congested area while the ESW weld is in progress
